Re: Morrow County  
OHD980569230  
(Former) HPM Plant #1  
Notice of Violation

On July 17, 2004, Ohio EPA conducted an investigation and review of the property located at 394 Lincoln Avenue in Mt. Gilead, Ohio. During this investigation and review, Ohio EPA was represented by Phil Farnlacher, Division of Solid & Infectious Waste Management and me. The current property owner, Mid-Ohio Sanitation & Recycling, was represented by Mr.

During the investigation and review, several tanks and containers of wastes and/or discarded materials were viewed and photographed. Below is a listing of some of these wastes or discarded materials and their locations. This listing is not all inclusive:

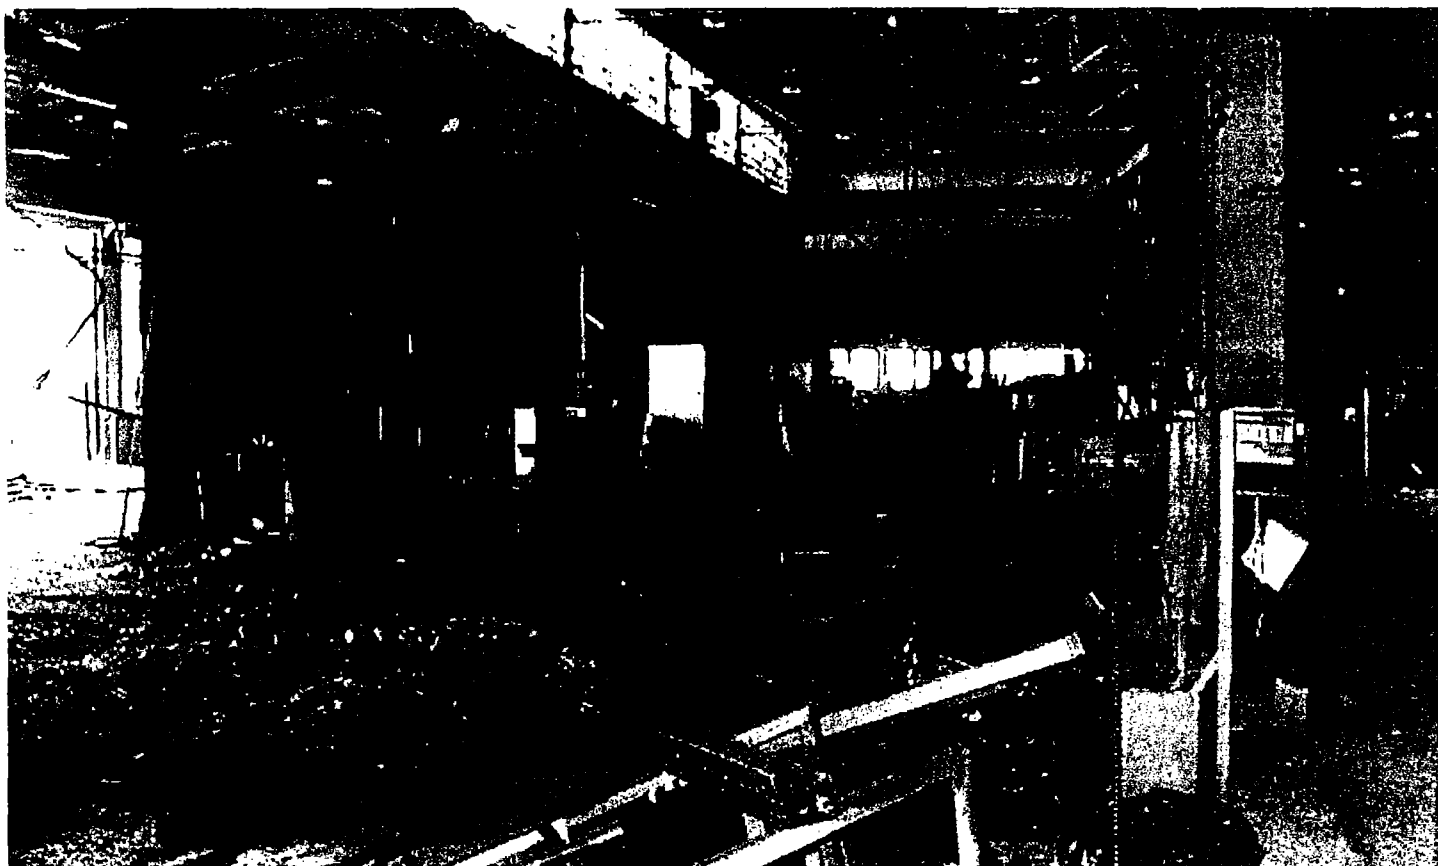
Former HPM Plant 1; 7-15-04; equipment and waste pile located on north side of middle area of building, near opening in building (NE).

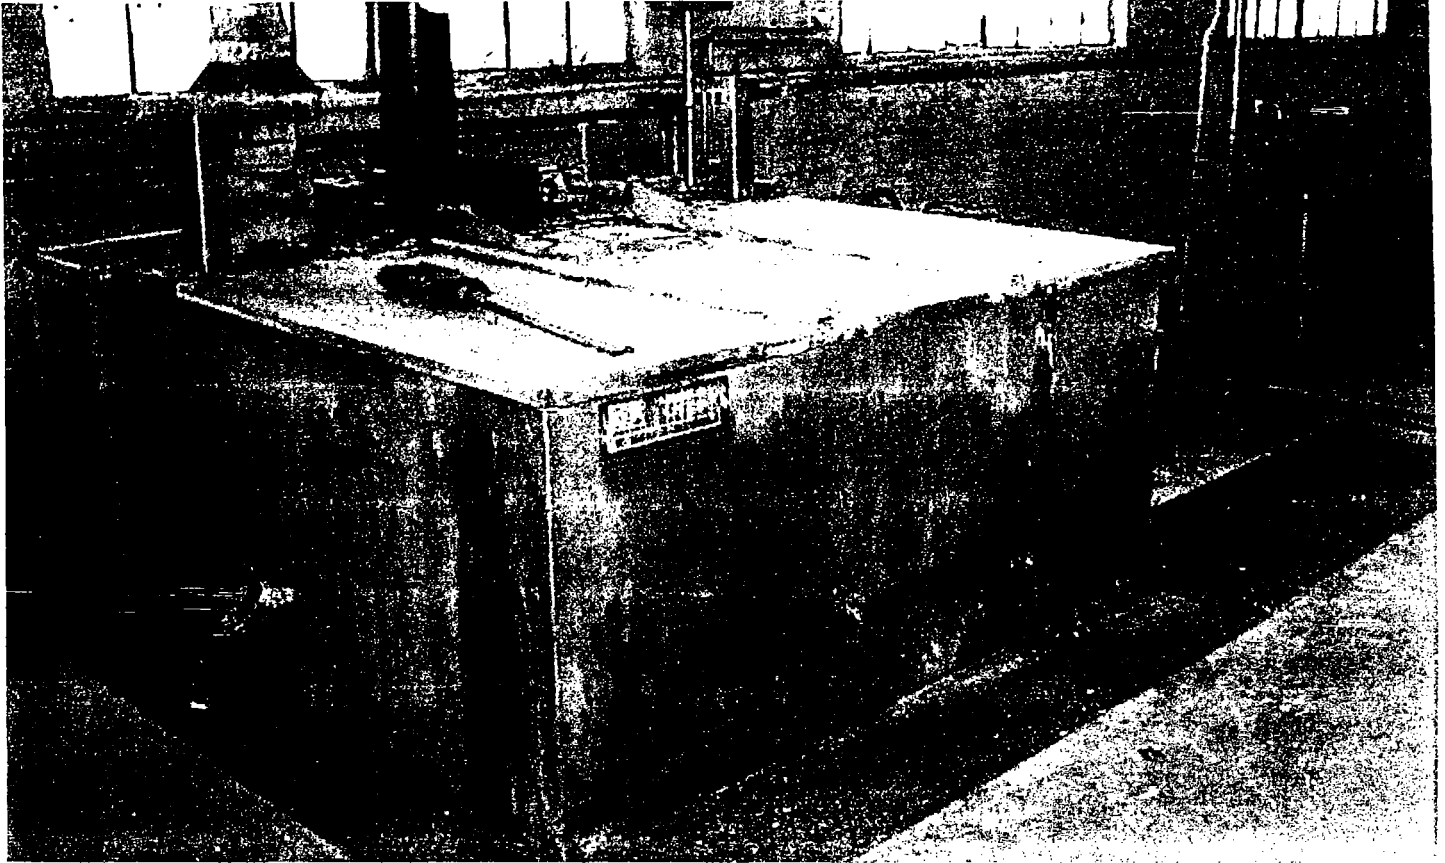
Former HPM Plant 1; 7-15-04; equipment on north side of middle area of building that was located in a concrete vault/pit, all liquid wastes and main part of equipment reportedly already removed by TIS as it was deemed very valuable (NE).

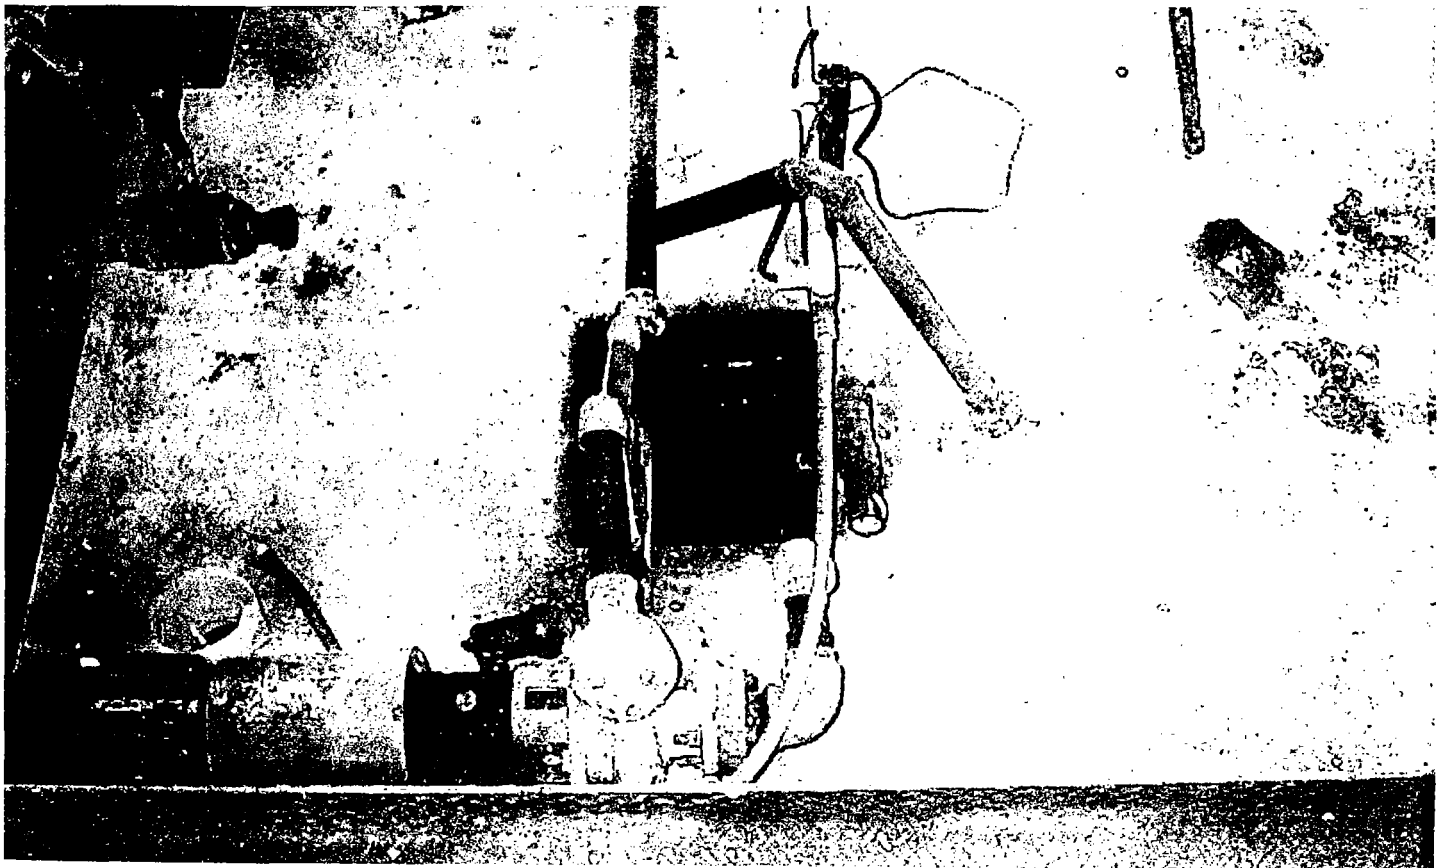
Former HPM Plant 1; 7-15-04; former vault/pit area for a piece of equipment located on north side of middle area of building reportedly removed by TIS, all liquid waste also reportedly removed, notice liquid in sump area/floating debris.

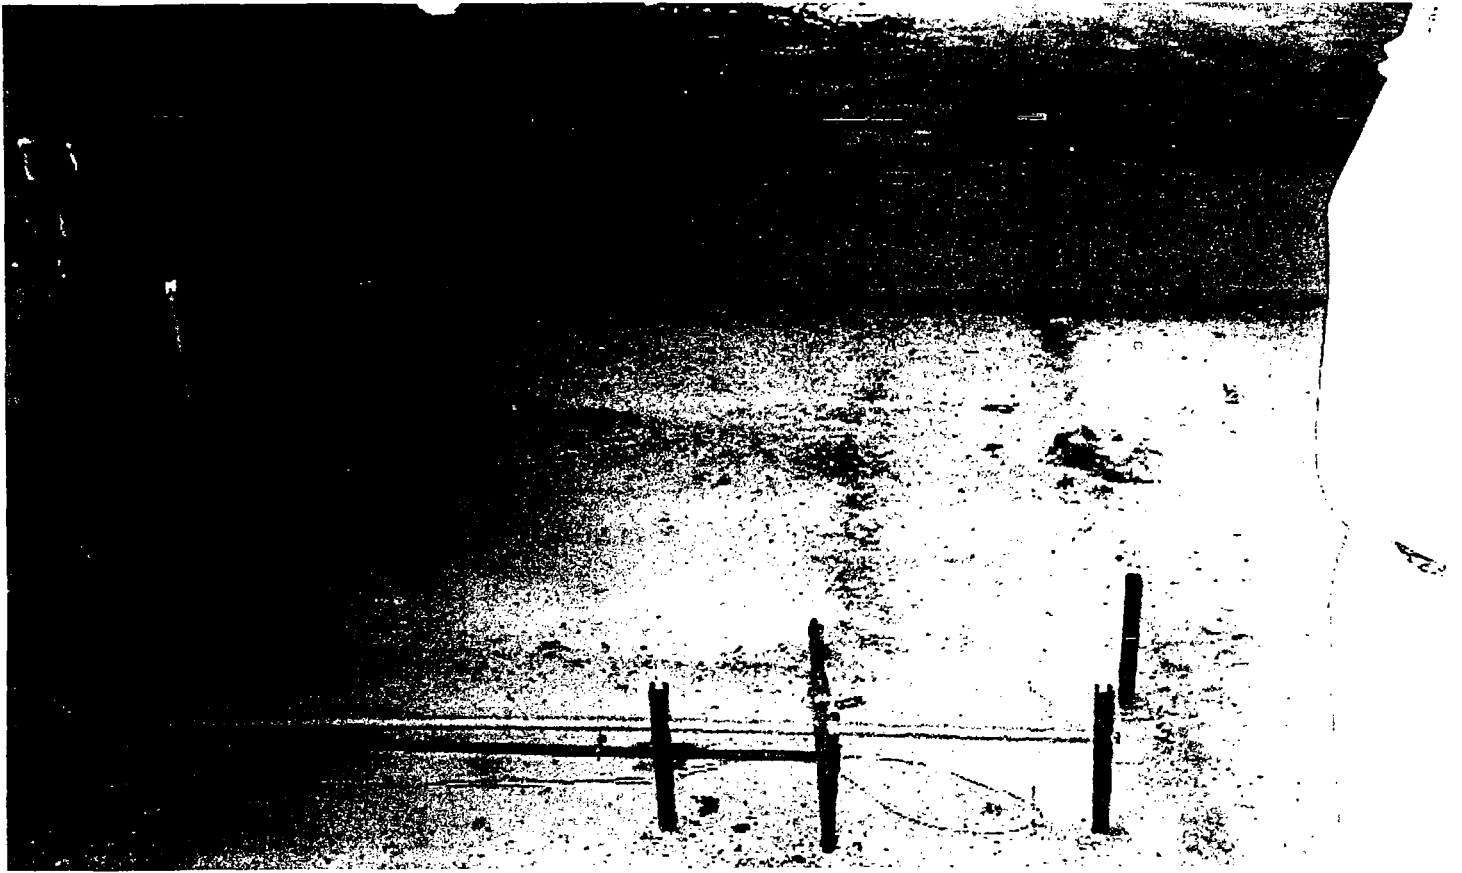
Former HPM Plant 1; 7-15-04; former vault/pit area for piece of equipment located on north side of middle area of building, equipment and all wastes from this area were reportedly removed by TIS (E).

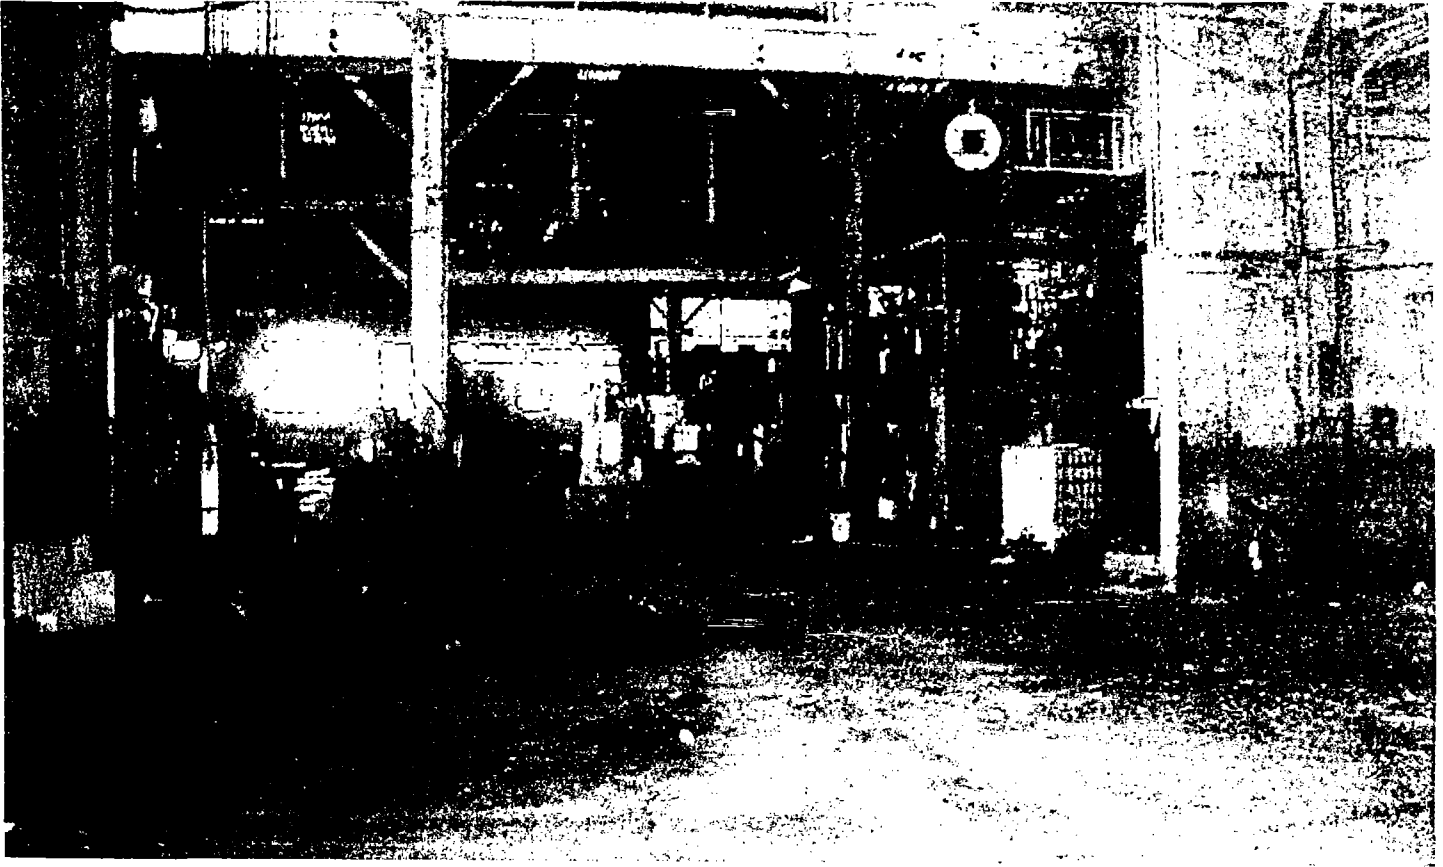
Former HPM Plant 1; 7-15-04; equipment of unknown contents located on south side of east end of building (E).

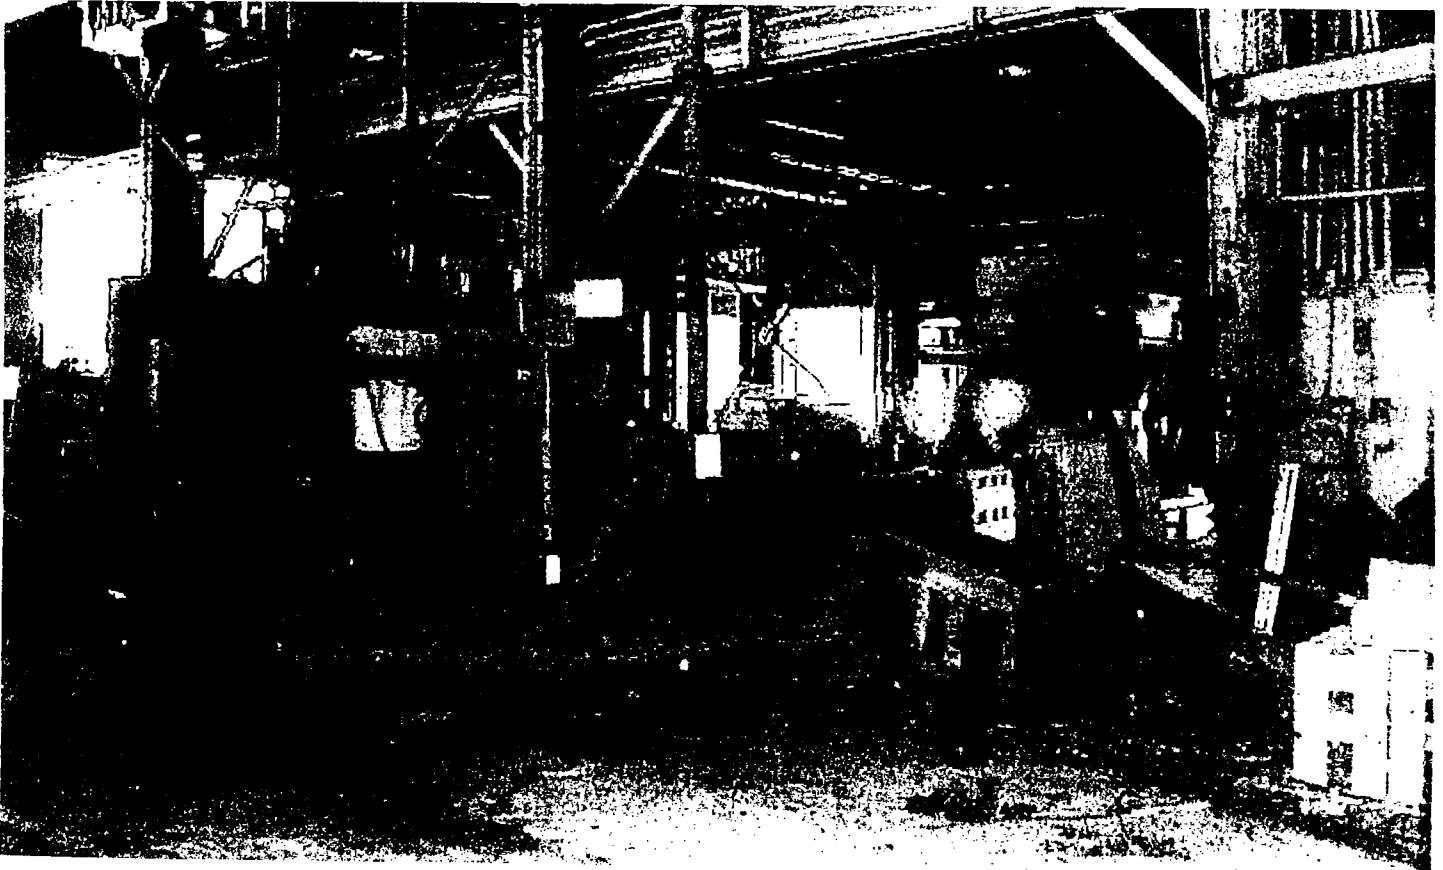
Former HPM Plant 1; 7-15-04; equipment with unknown contents located on south side of east end of building (SE).

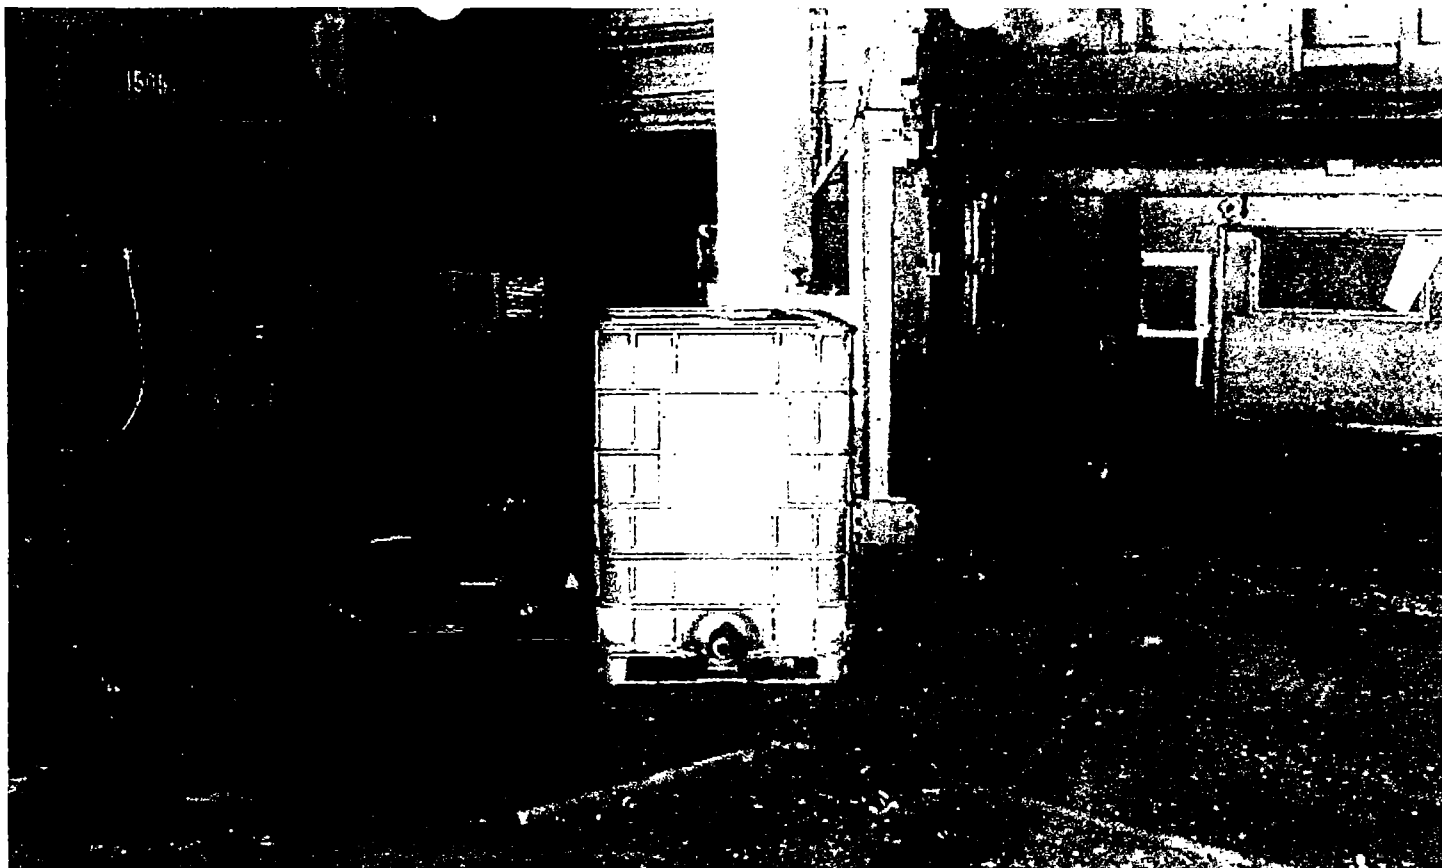
Former HPM Plant 1; 7-15-04; partially filled tote of unknown contents (1 @ ~300 gallons) located on south side of east end of building (S).

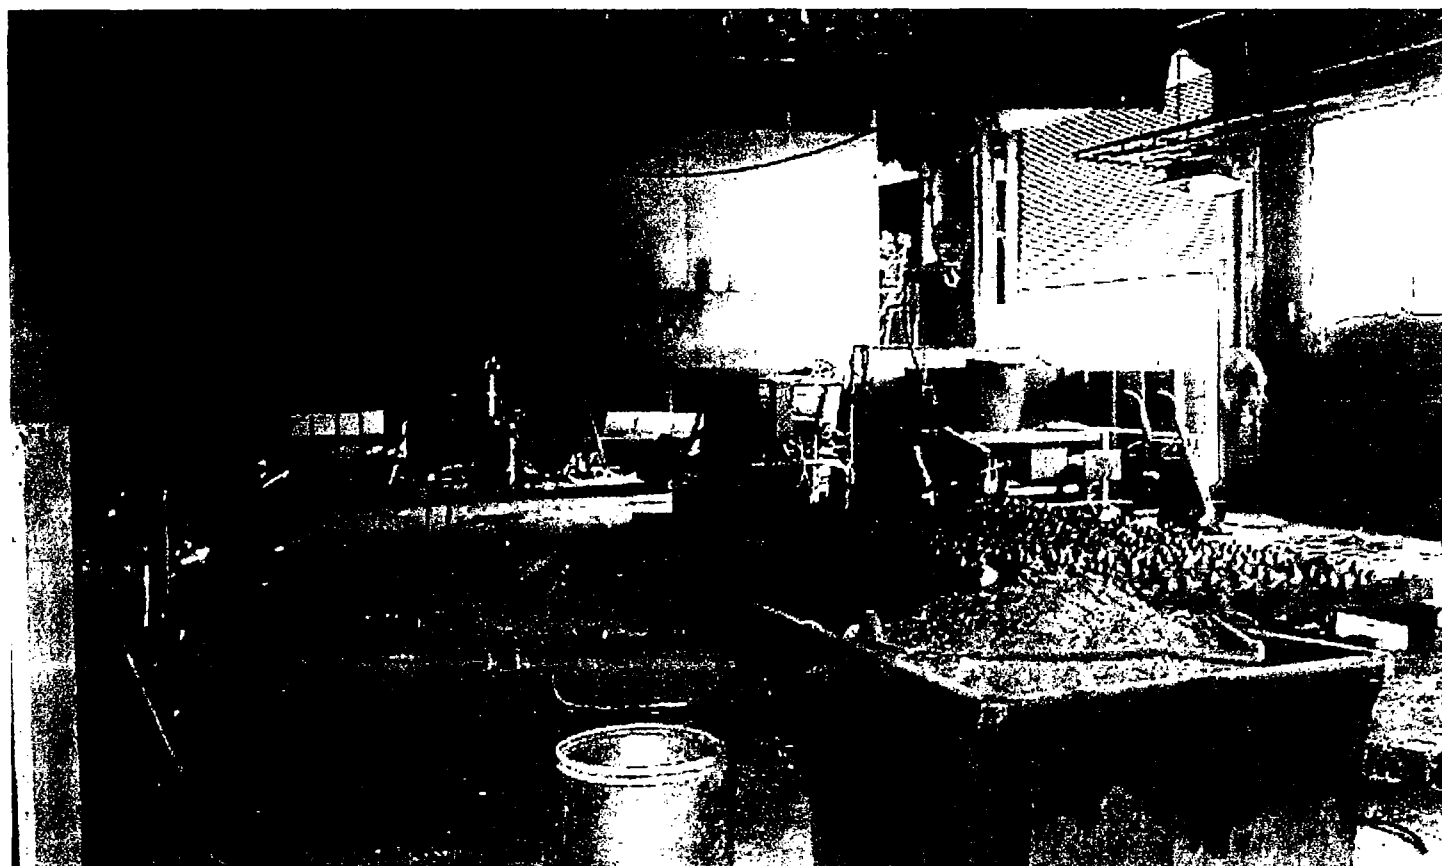
Former HPM Plant 1; 7-15-04; containers of unknown wastes located in the middle of the east end of building near the open door area (NE).

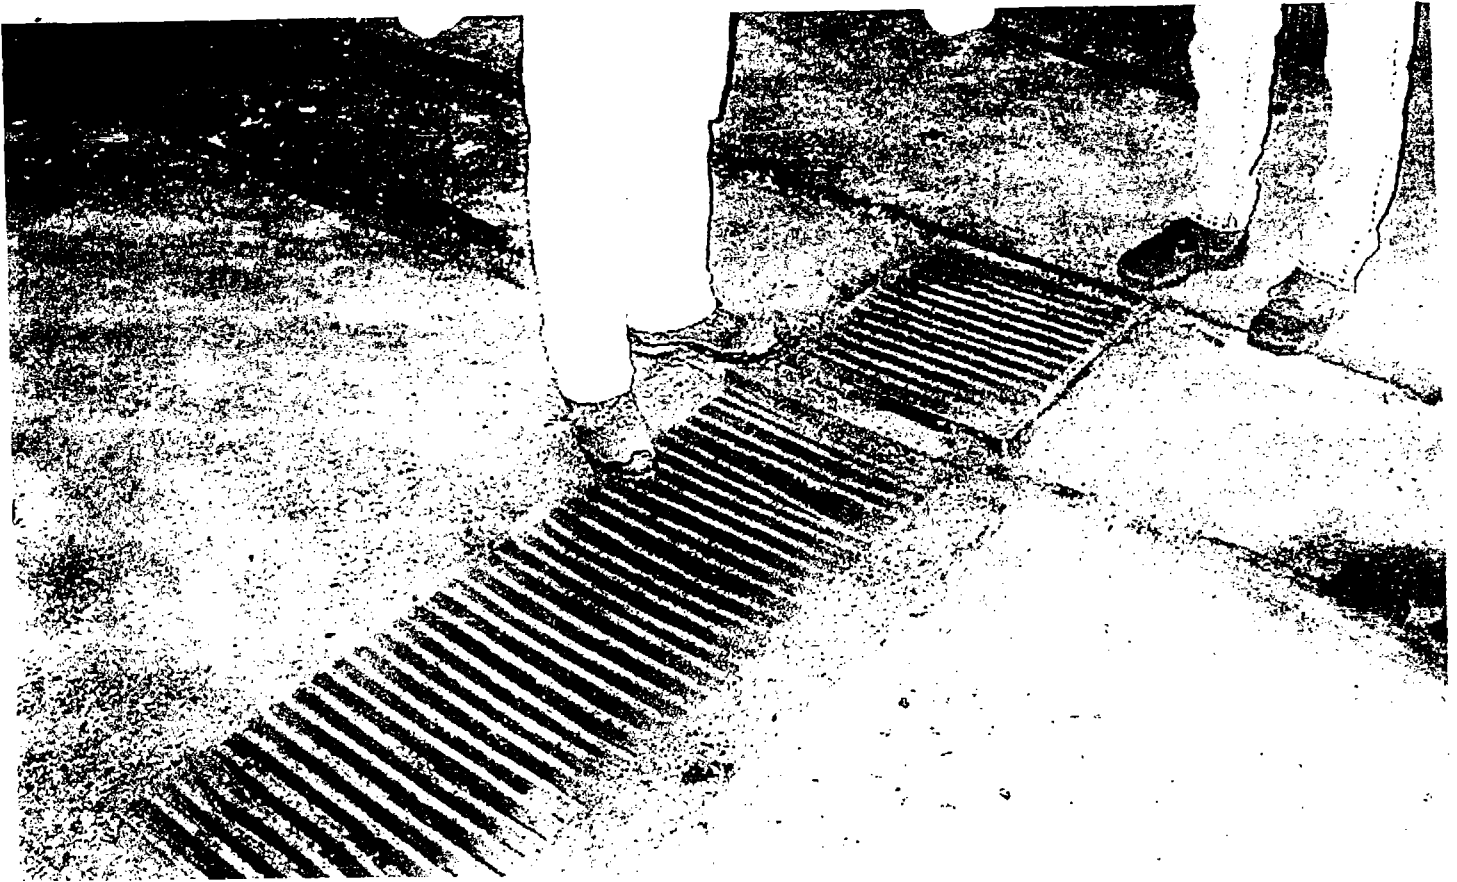
Former HPM Plant 1; 7-15-04; grated sump/drain area in middle of east end of building, if any drainage occurs it is not known to where (NW).

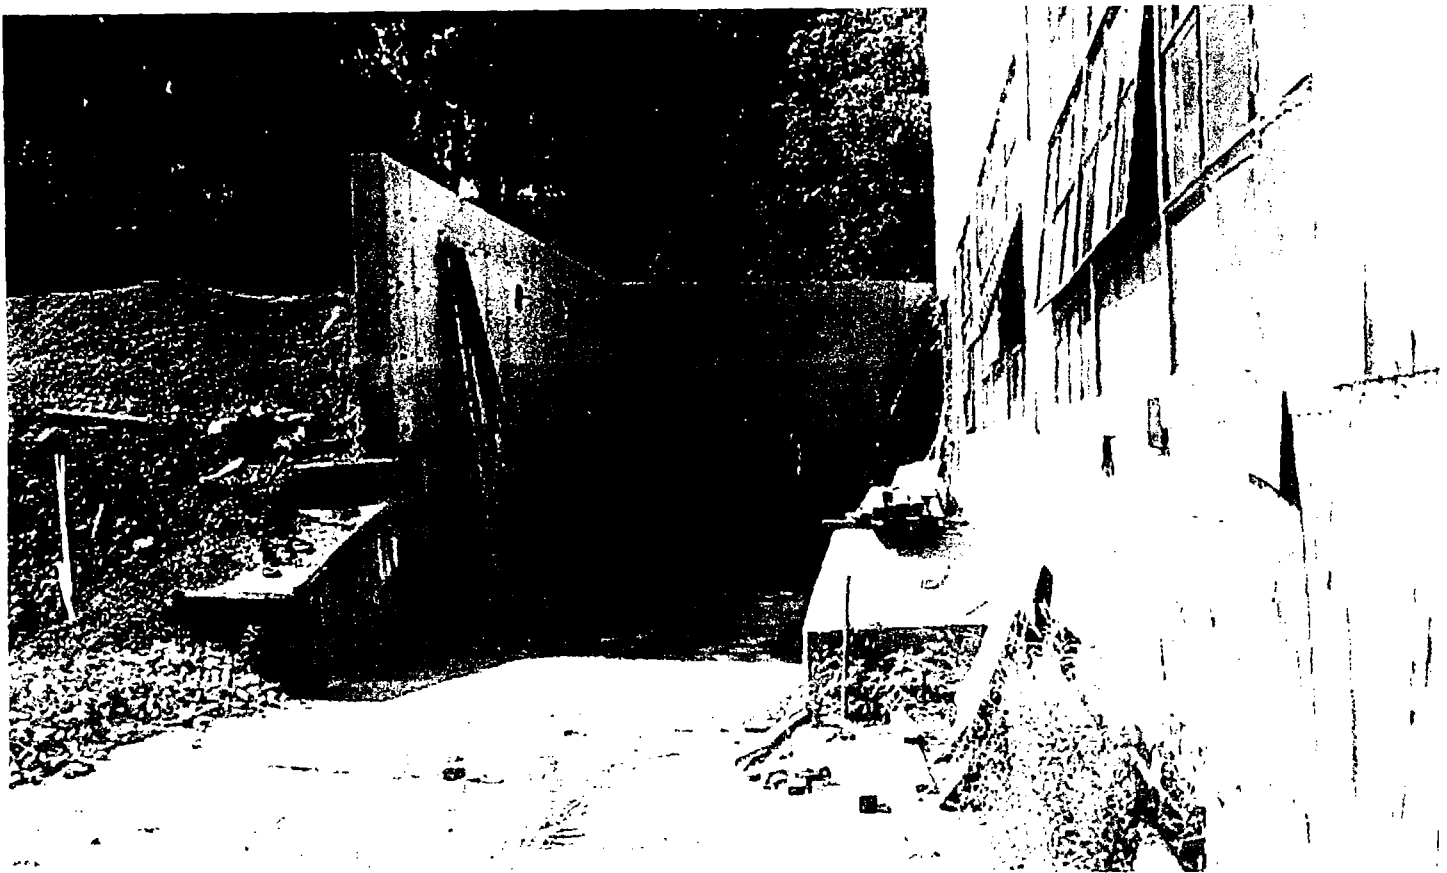
Former HPM Plant 1; 7-15-04; area under construction for future management of solid wastes/recyclables (S).

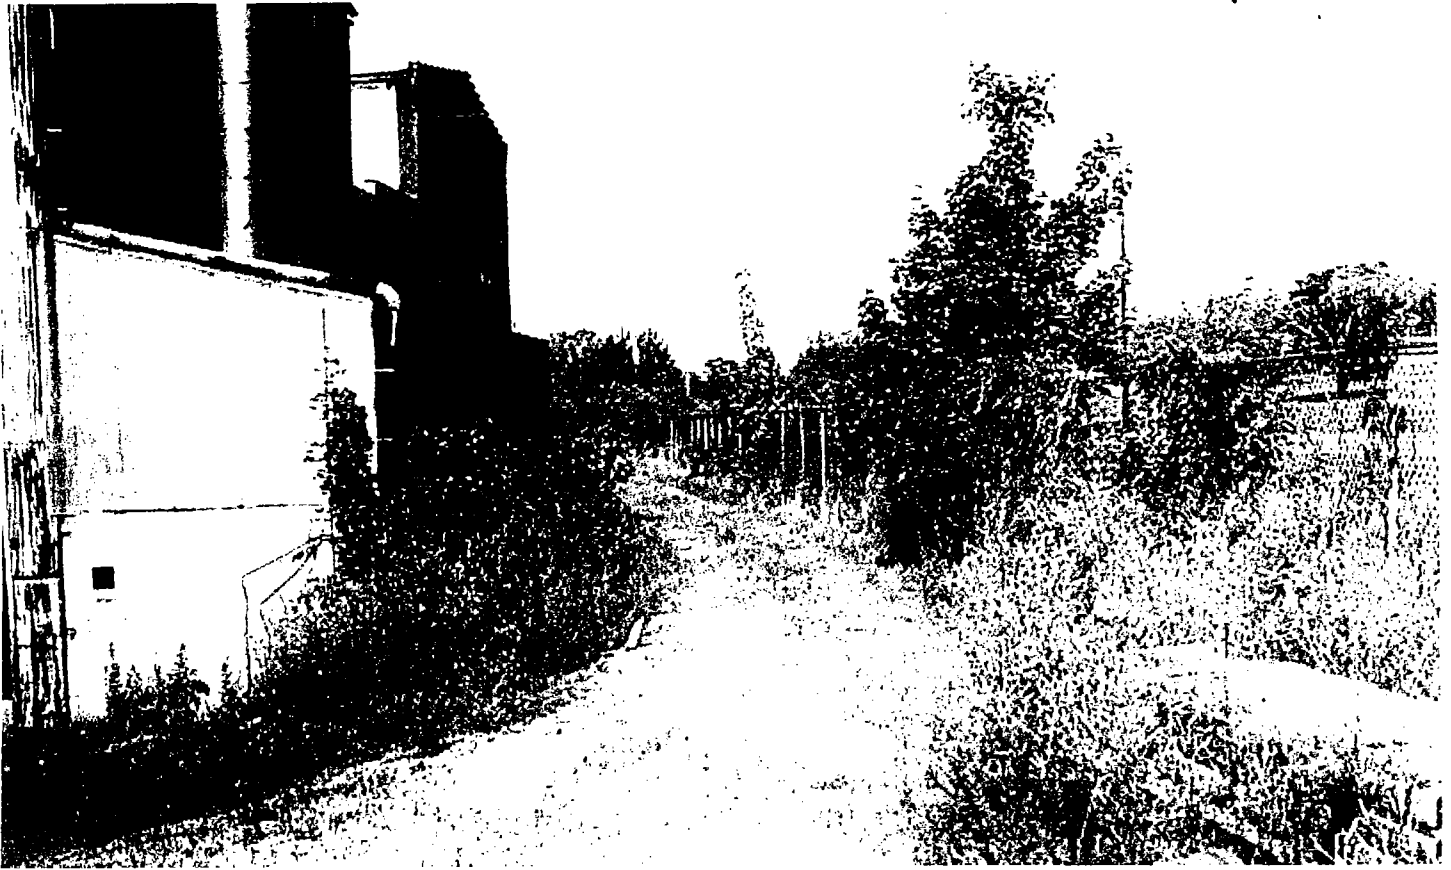
Former HPM Plant 1; 7-15-04; view of north side of building from the far east end, area is surrounded by chain-link fence (W).

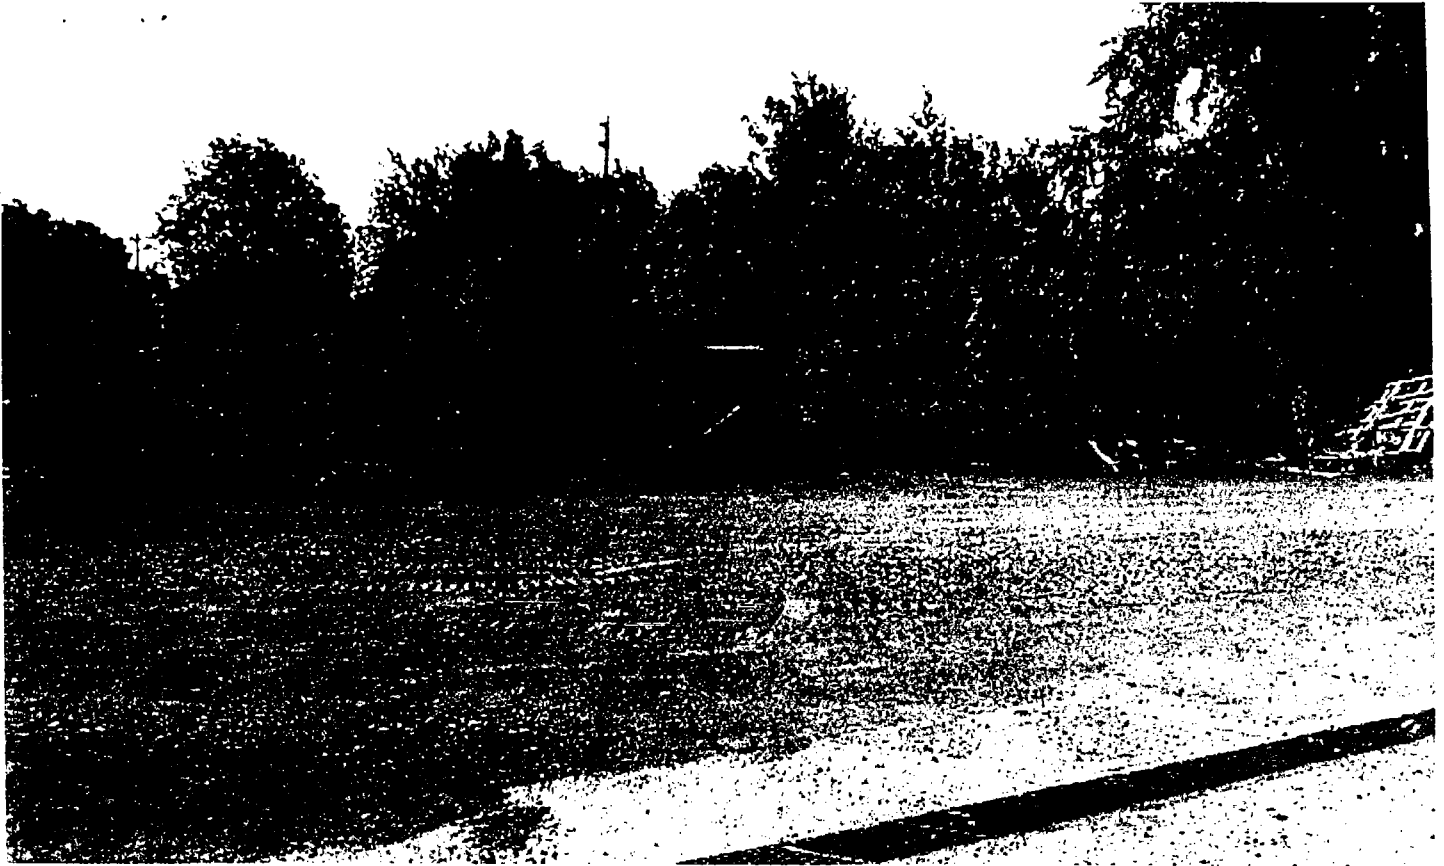
Former HPM Plant 1; 7-15-04; view of eastern end of property, fueling tank in photo is reportedly empty (E).

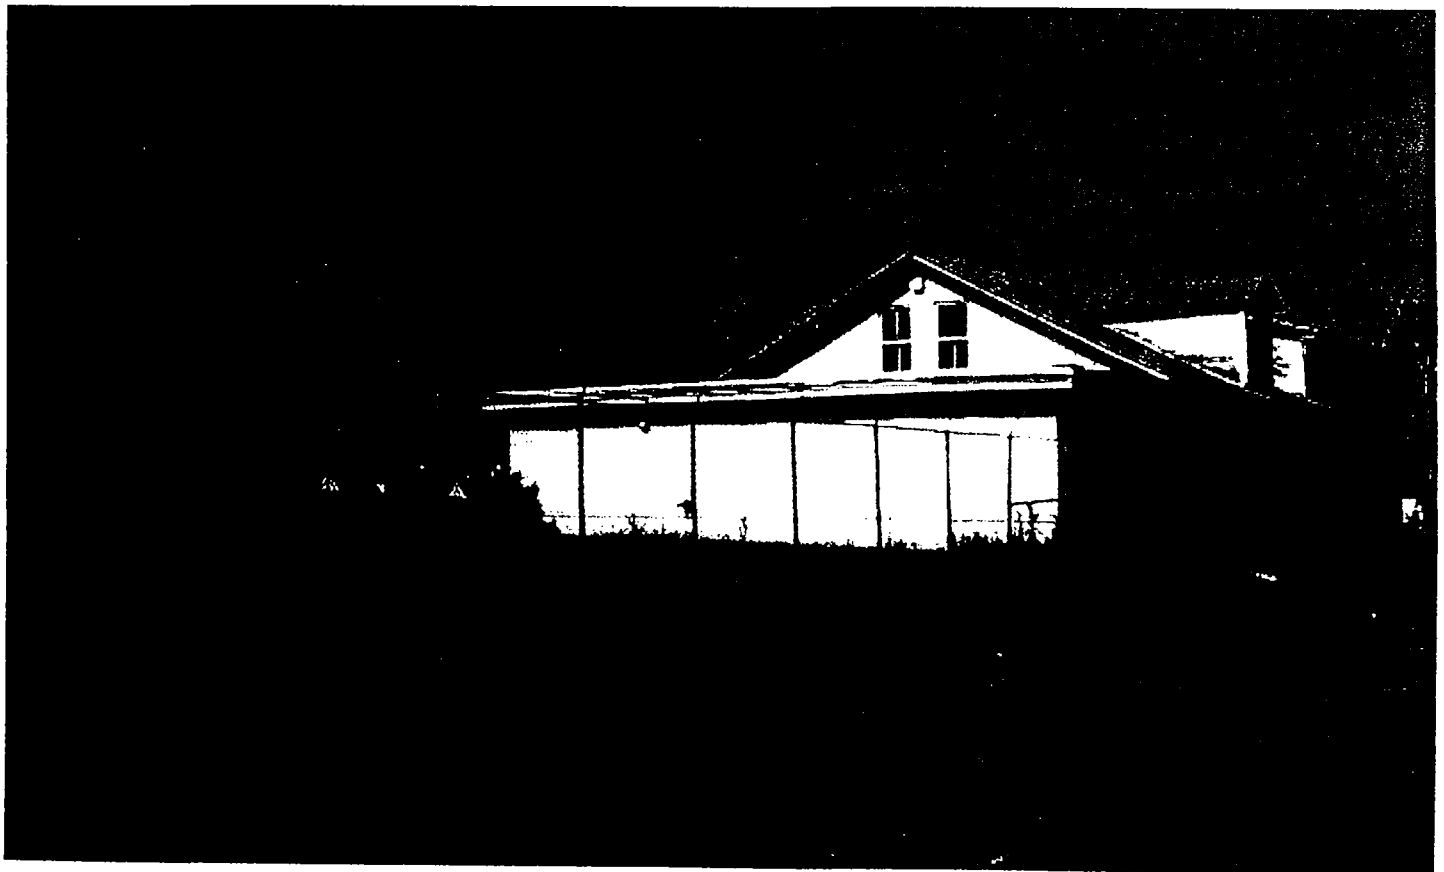
Former HPM Plant 1; 7-15-04; view of building and fueling tank located across the drive on the south side of the main building, fueling tank reportedly is empty (SW).

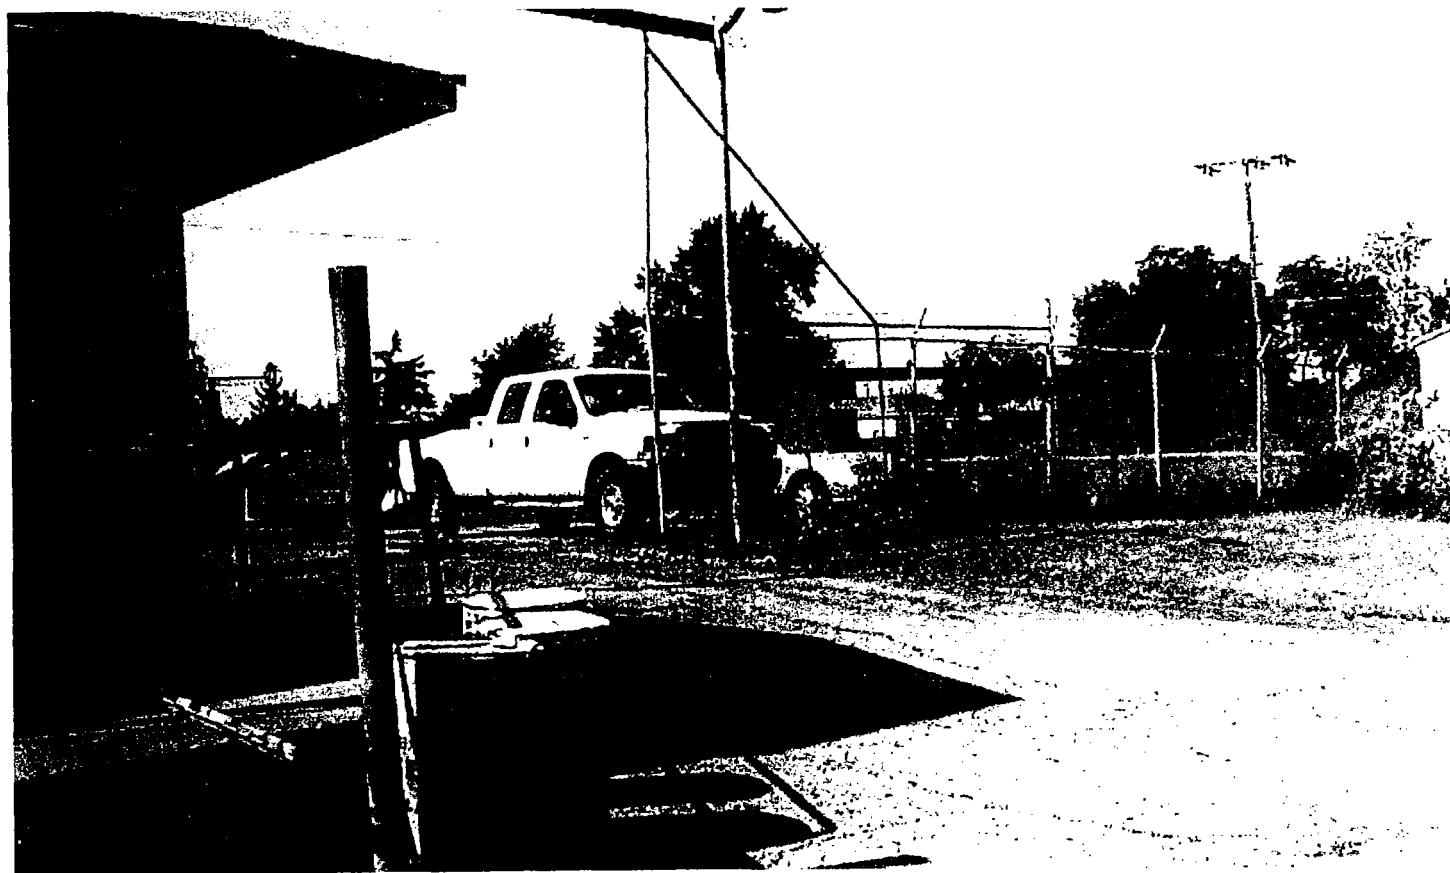
Former HPM Plant 1; 7-15-04; guard building and gated fence on south end of property (SW).
